MSFC Investigations on MISSE-8

Miria M. Finckenor

National Space & Missile Materials Symposium

June 2015

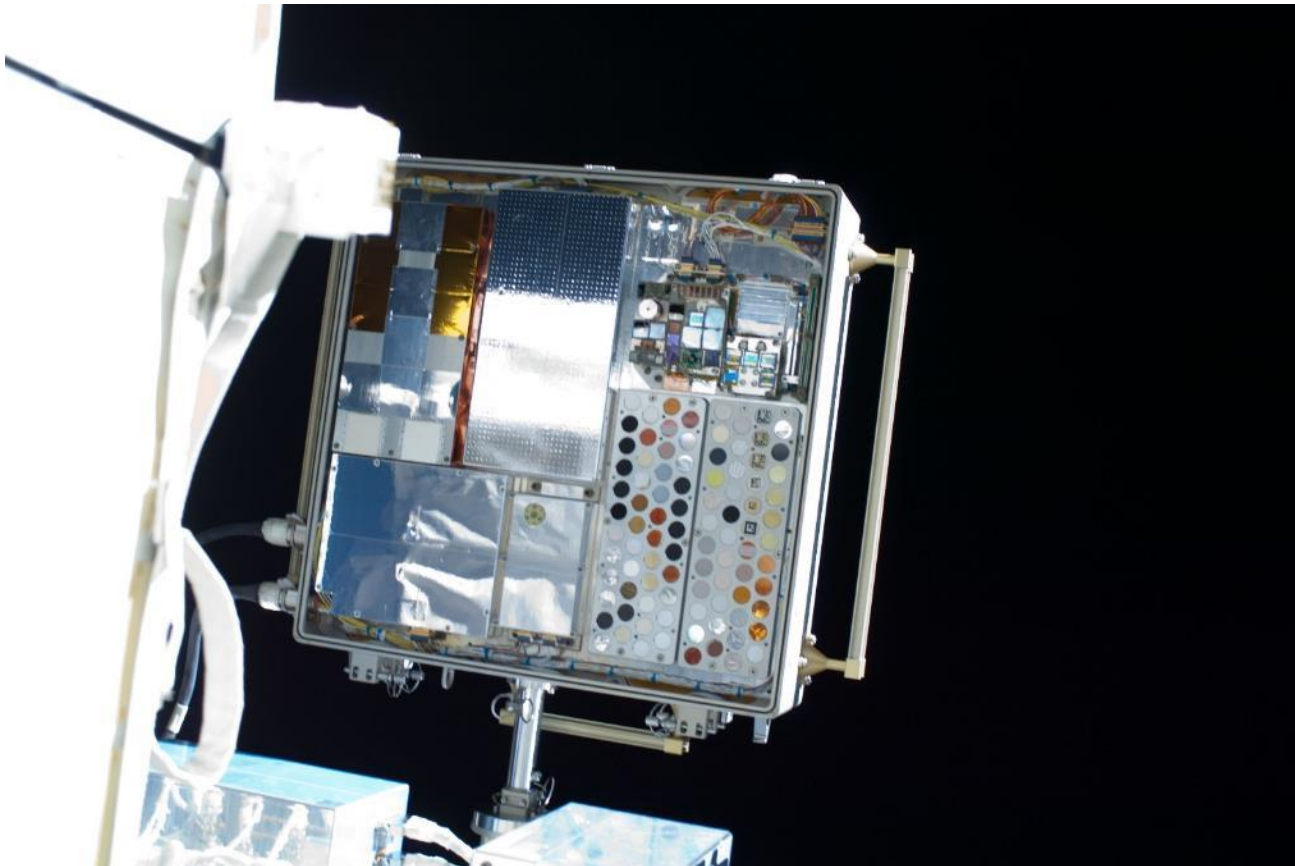
MISSE-8 nadir side with MSFC passive trays in lower right.

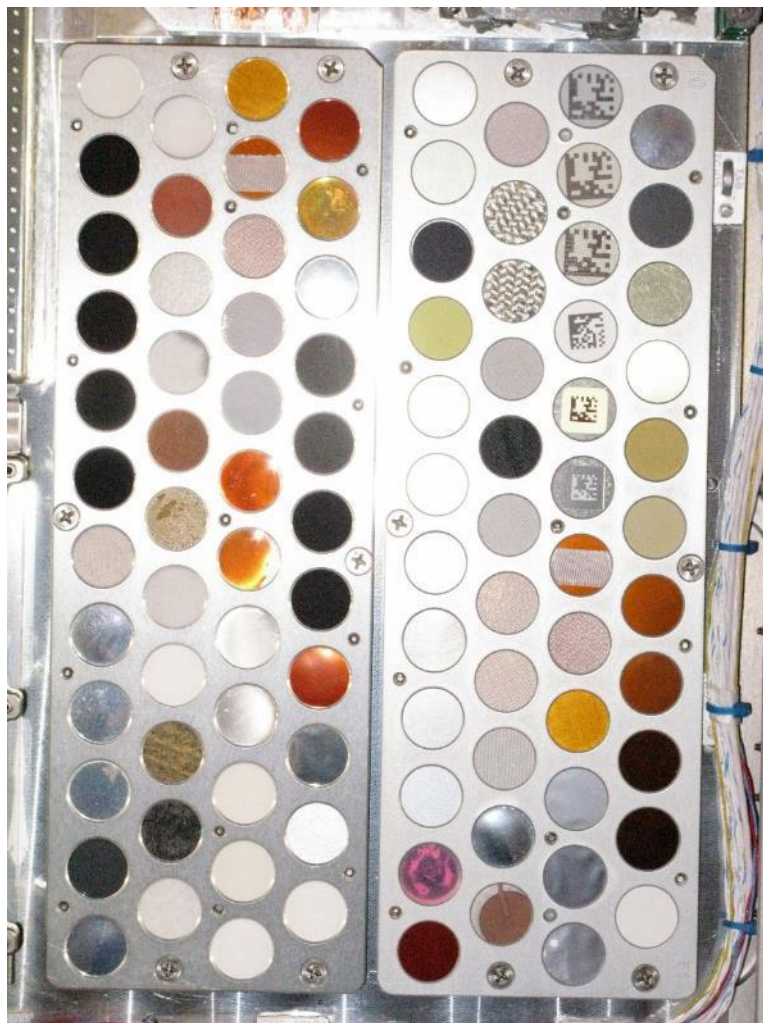
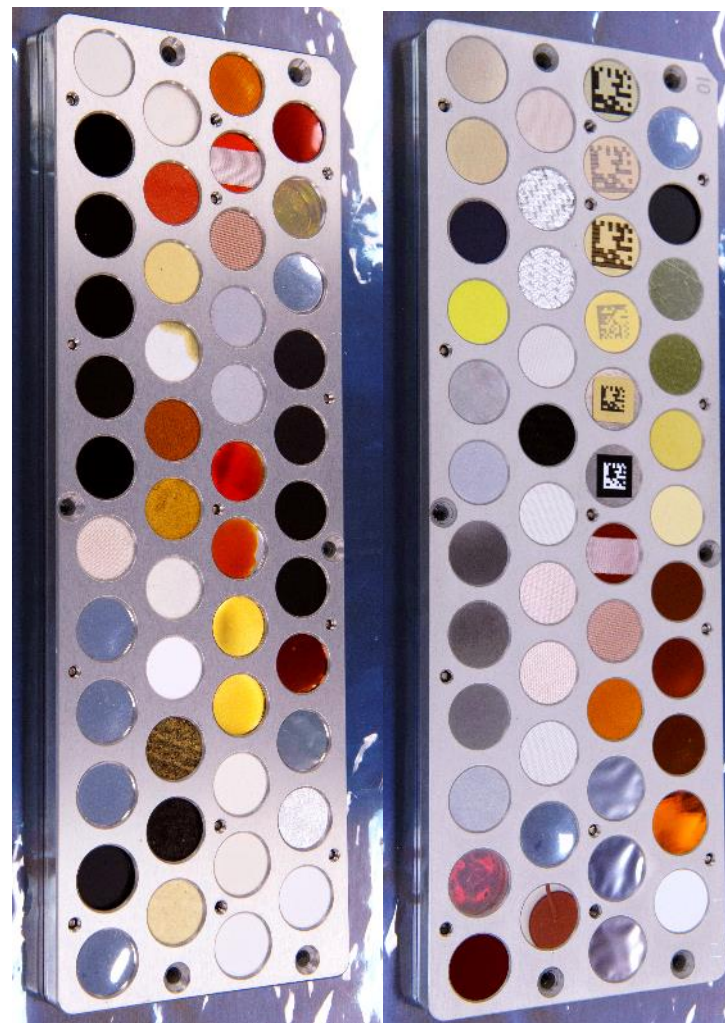
Pre-flight

Post-flight

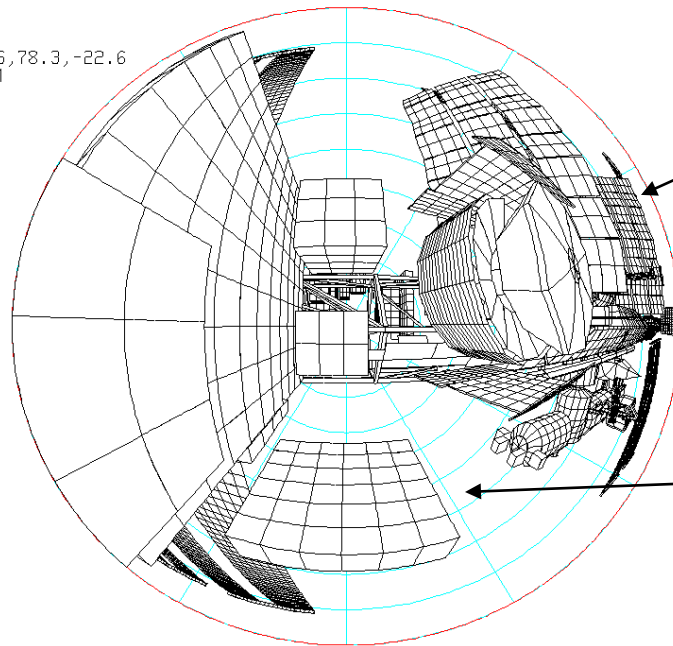
MISSE-8 Nadir Samples Hemispherical View

Location : -0.26,78.3,-22.6
Direction : 0,0,1

AMS-2

MISSE Ram/Wake element
MISSE-7 shown
OrMATE on orbit

Atomic Oxygen Fluence $3.6 \pm 0.1 \times 10^{19}$ atoms/cm²

Determined by mass loss and thickness loss of Kapton HN

Very low fluence due to nadir location and ISS shielding

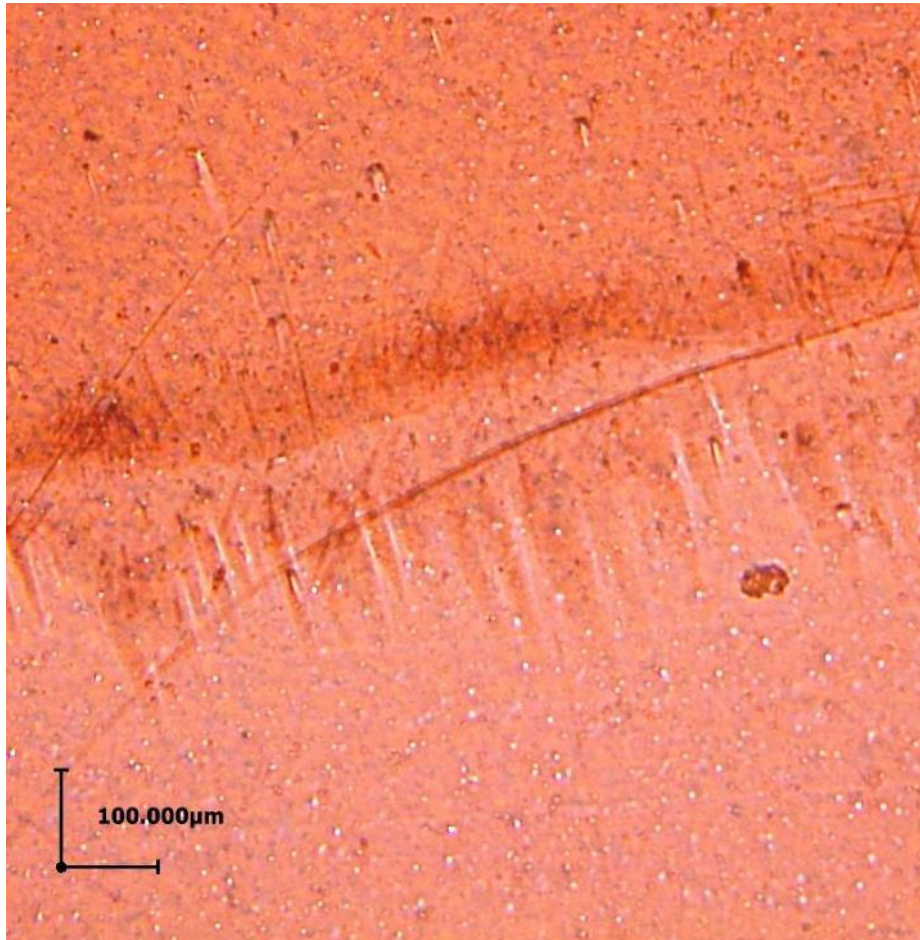
Grazing Atomic Oxygen Erosion

Exposed Area

Protected by holder

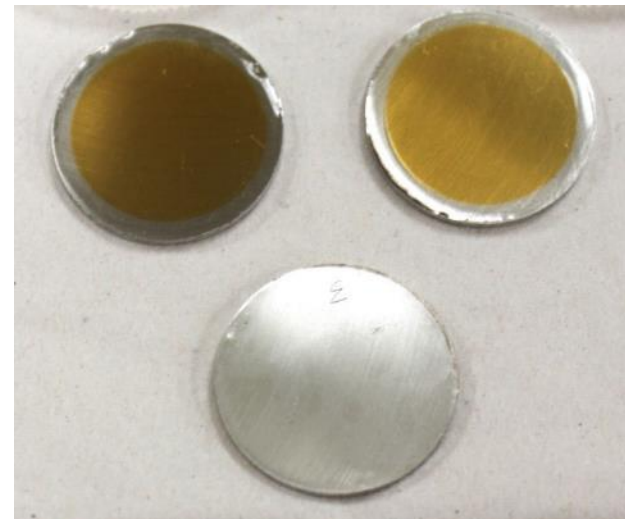
UV darkening observed on beta cloth, ionic liquid epoxy samples, part markings, and others

Ionic liquid epoxy – Flight

Control

Ultraviolet Radiation Exposure – exact dose unknown at this time

This suggests a minimum of 500 equivalent sun hours (ESH).

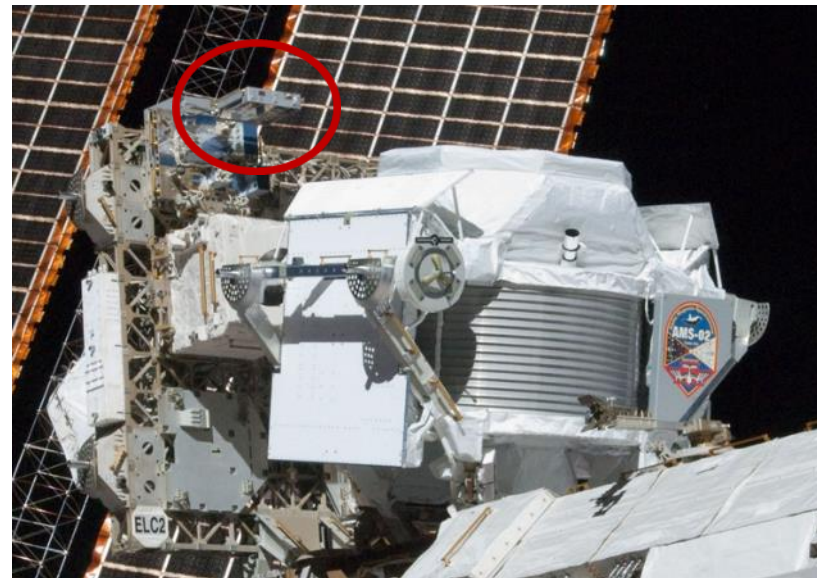
- Concern prior to the STS-134 flight that the Alpha Magnetic Spectrometer AMS-2 would significantly outgas onto MISSE-8 and other line-of-sight hardware.
 - White silicone paint, unbaked composites, polypropylene fleece
- Predicted deposition on MISSE-8 nadir and wake-facing experimental sample trays was 40-100 Angstroms per year in addition to normal ISS background of 130 Å/yr.

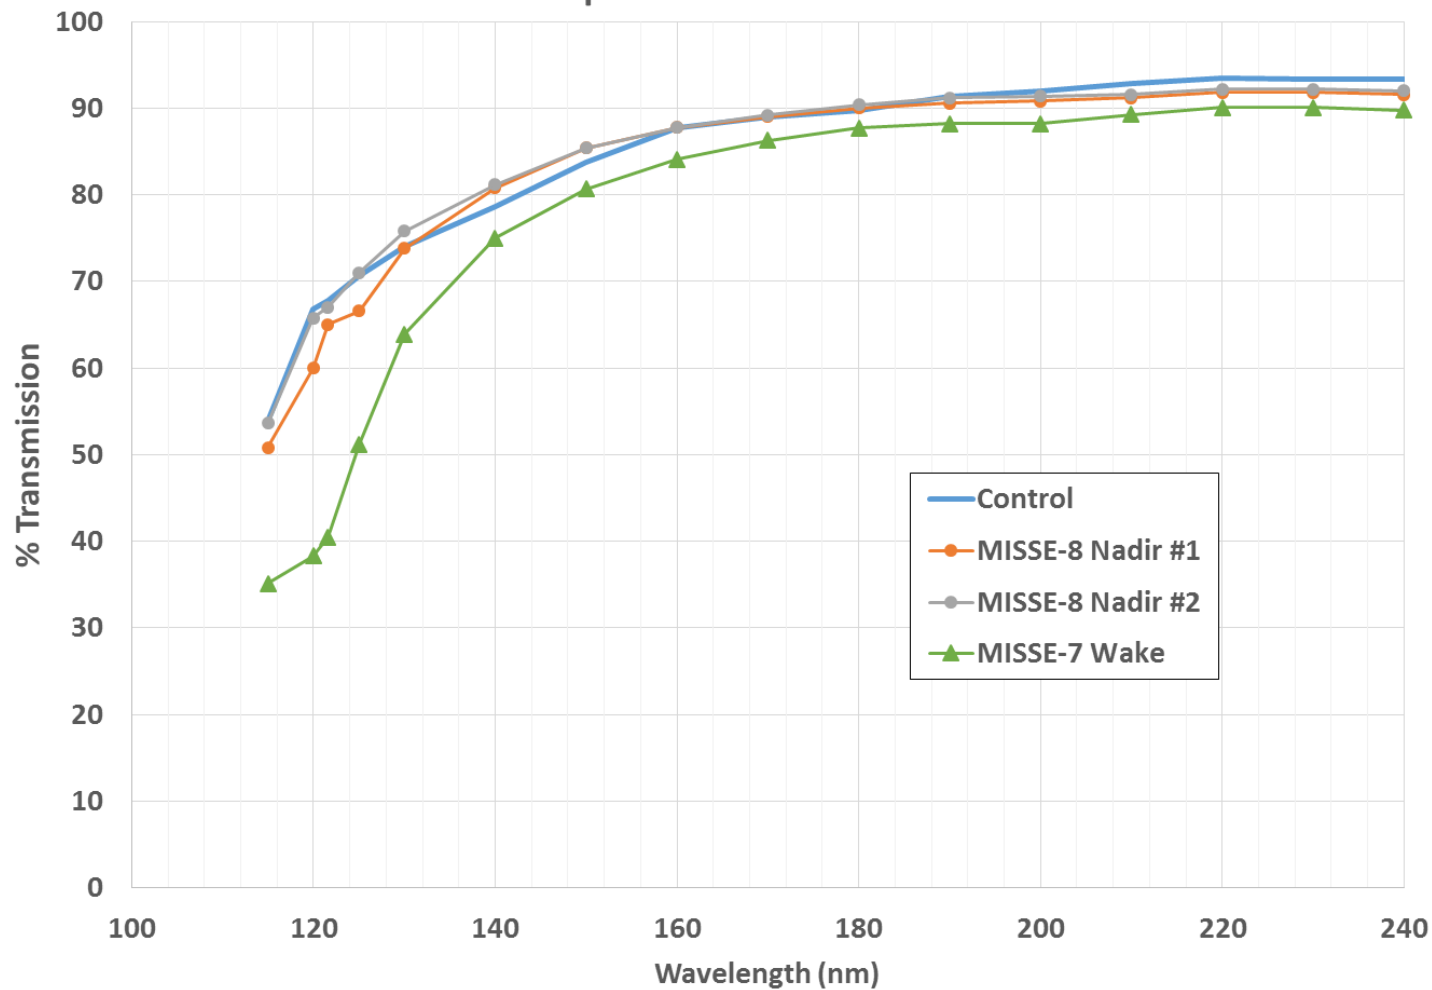
MISSE-8 MgF2 Window Transmission
Compared to MISSE-7 Wake

- Very little observed on MgF2 and fused silica windows, certainly less than 250 Å
- Glenn Research Center's analysis of Second Single Events Upset Xilinx-Sandia Experiment (SEUXSE) hardware in agreement
- “Comparison of Spacecraft Contamination Models with Well-Defined Flight Experiment” by Gary Pippin, NASA/CR-1998-208800
 - ESCA analysis of Long Duration Exposure Facility trays E10 (ram), A4 (wake), and C6 (in between, some AO exposure)
 - Contaminant fixing on aluminum strongly dependent on AO fluence

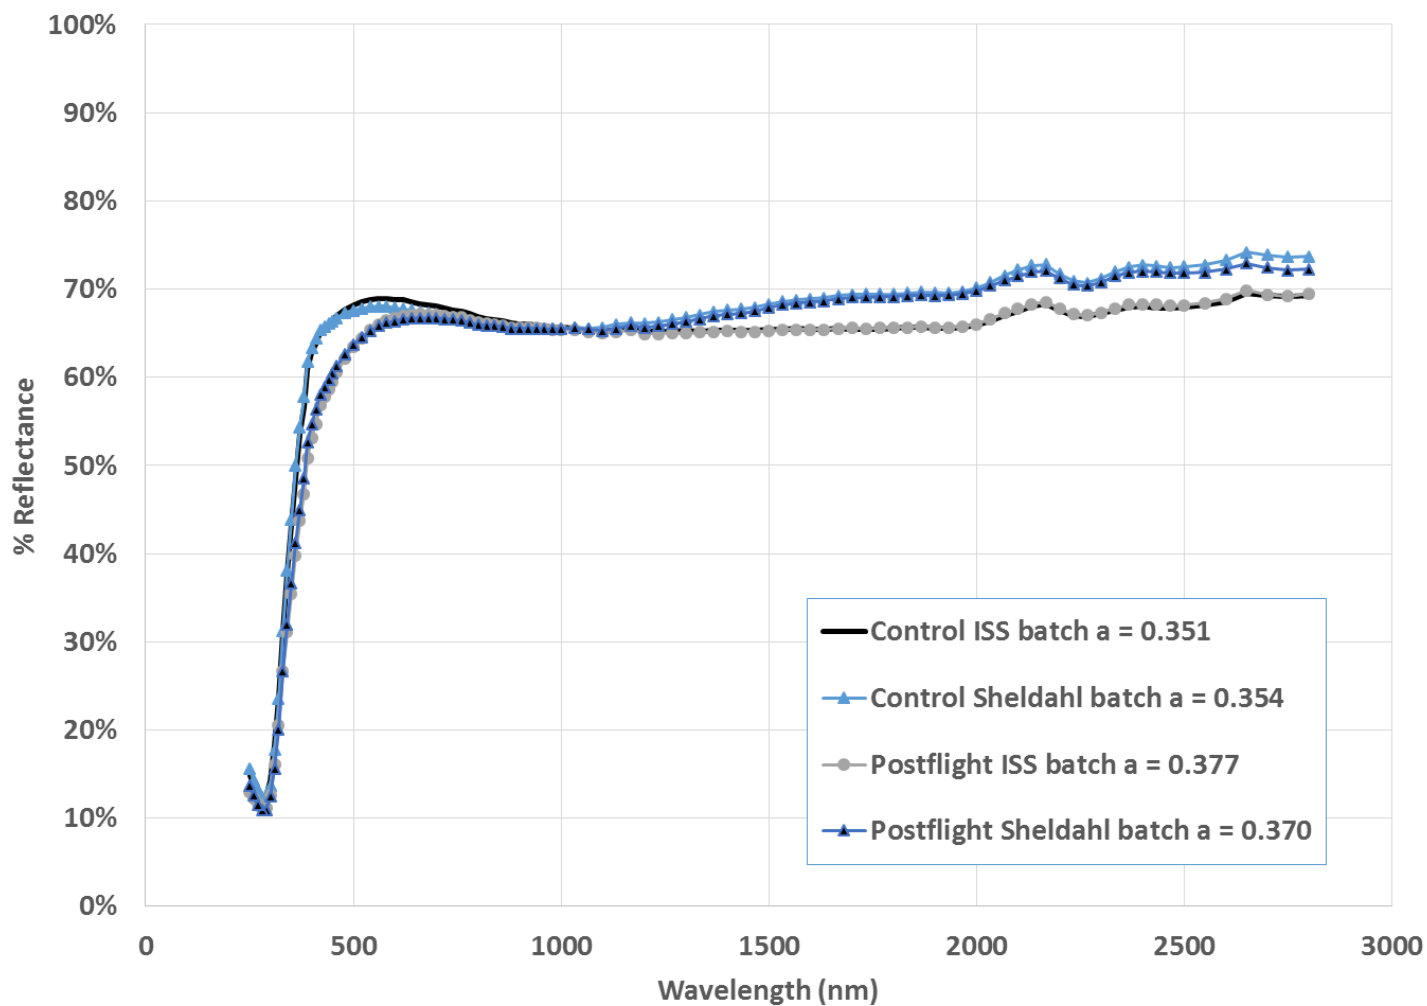
MISSE-8 Beta Cloth

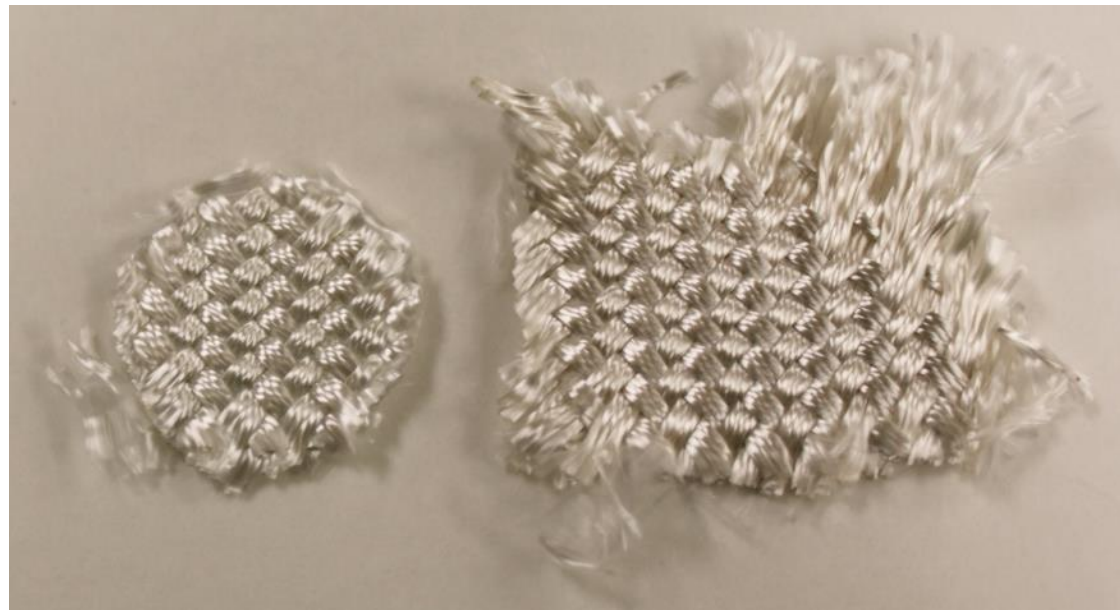
Davlyn fiberglass sleeve

- Some bleaching noted in reflectance curves, not really apparent by visual inspection
- Mass loss indicates possible erosion of sizing

Flight

Control

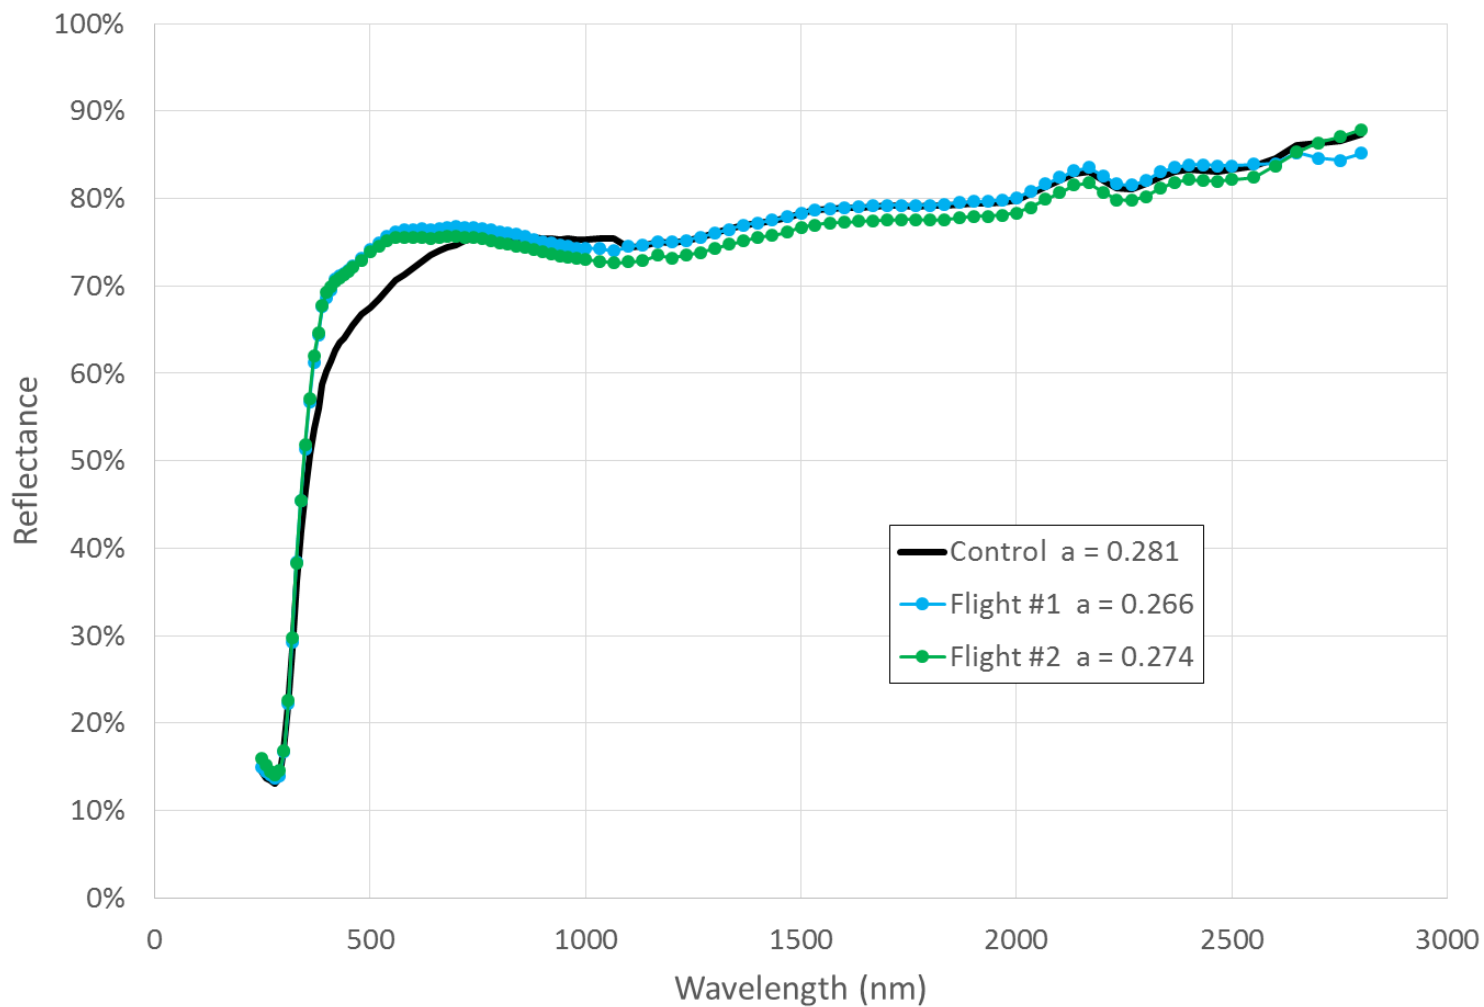
MISSE-8 Davlyn Fiberglass Sleeve

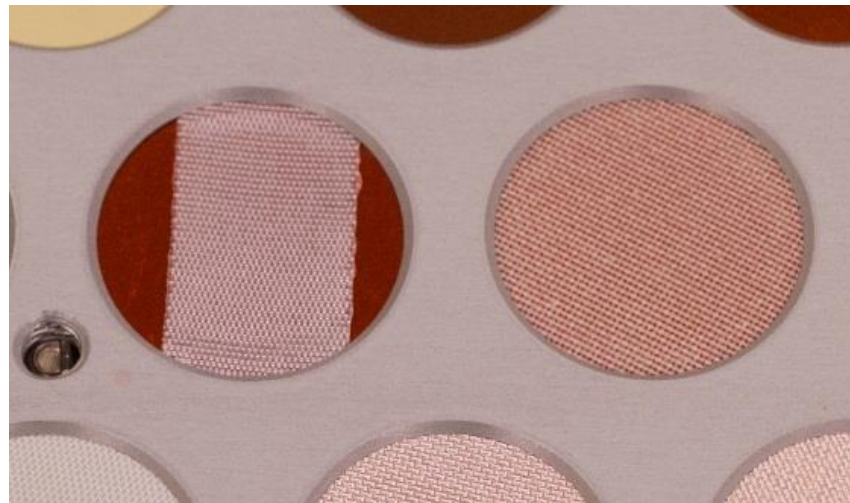
Permacel and Intertape Glass Cloth Tapes

- Permacel P-213 tape is obsolete, Intertape 4617 is substitute for sharp edge mitigation and other protective uses on ISS hardware.
- Even though MISSE-8 had low AO fluence, mass loss indicates same level of protection for Kapton underneath.
- Permacel solar absorptance slightly increased from 0.48 to 0.51
- Intertape solar absorptance negligible change from 0.62 to 0.63.

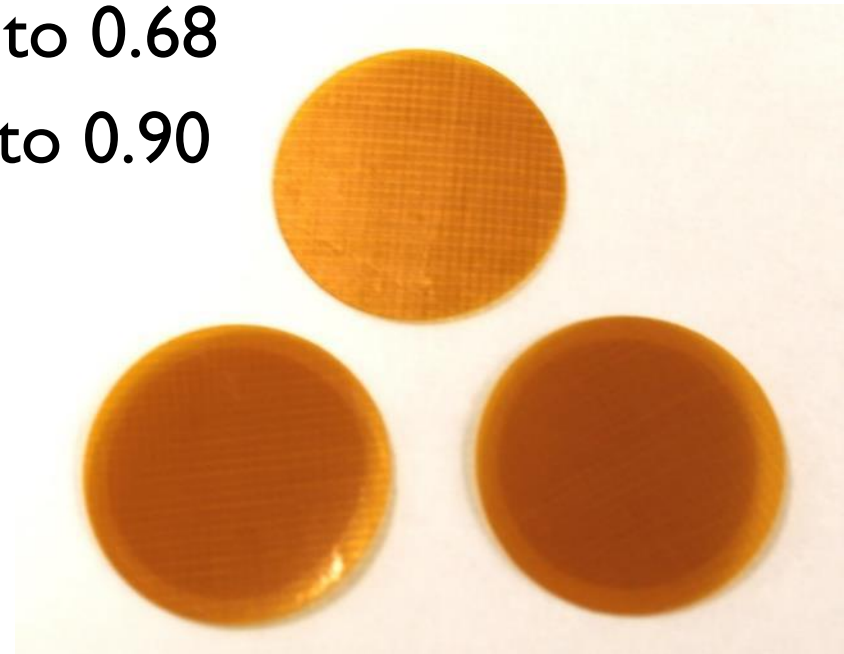
Solar array scrim cloth

- Higher than expected erosion rate
 - $\sim 6 \times 10^{-24} \text{ cm}^3/\text{atom}$
- Slightly higher optical properties
 - α increased from 0.65 to 0.68
 - ε increased from 0.88 to 0.90

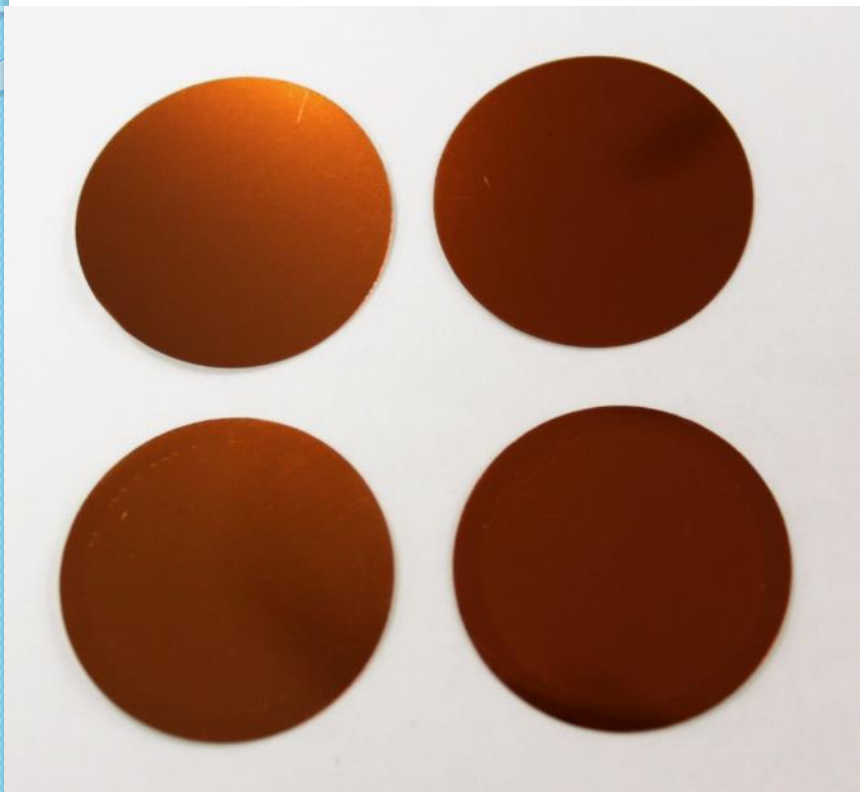
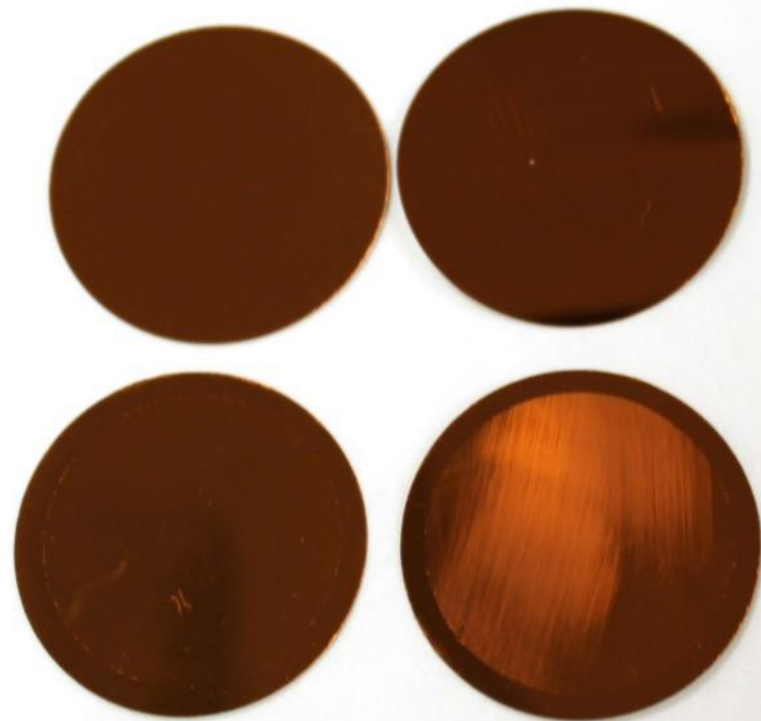
Control Samples

Flight Samples

ITO/SiOx/Kapton, newer ITO/Kapton, ITO/Kapton 1500 Ω /sq., ITO/Kapton 20K Ω /sq.

- PNI46635-001 “1500 Ω /sq.” sample and Multek ITO/SiO₂/Kapton unaffected
 - Control and flight PN I46635-001 was 1300 - 1400 Ω /sq
 - Control and flight ITO/SiO₂/Kapton 10 - 20 K Ω /sq
- Control newer Multek ITO/Kapton was 20 - 30 K Ω /sq, flight was 60 K Ω /sq., no visible change in appearance
- Older PNI46635-003 “20 K Ω /sq.” sample had same appearance of scratches, same degradation in conductivity, same degradation in solar absorptance as on MISSE-7

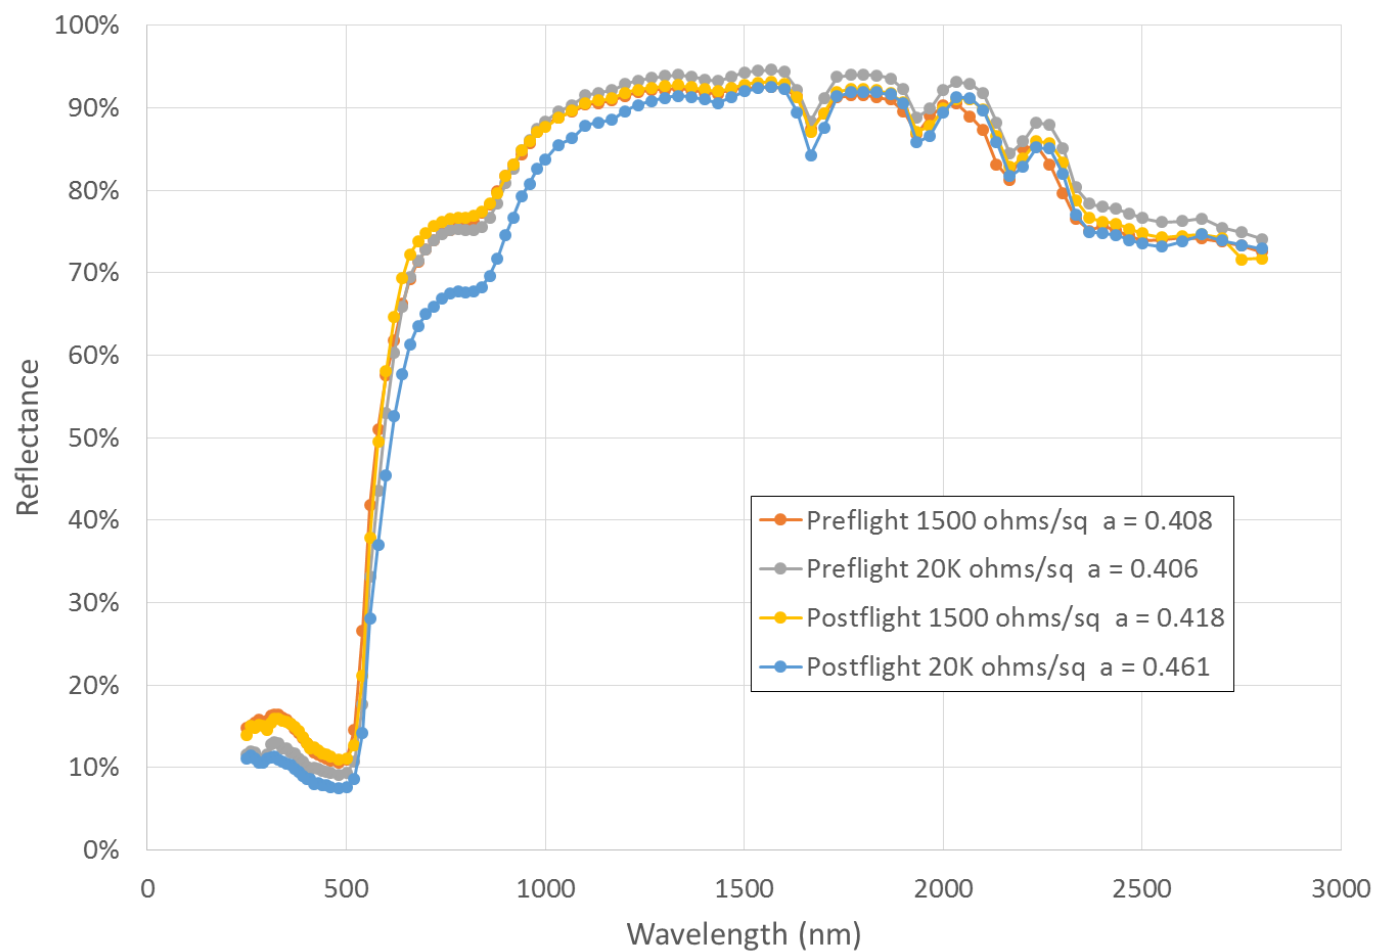
MISSE-8 Indium Tin Oxide / Kapton / Al film
